FINAL ROUND 10 DAM ASSESSMENT REPORT NIPSCO BAILLY GENERATING STATION COAL ASH IMPOUNDMENTS

AUGUST 17, 2012

Re: Round 10 Dam Assessment - Final Report
EPA Contract No. EP10W001313
NIPSCO Bailly Generating Station
Coal Ash Impoundments
Chesterton, Indiana

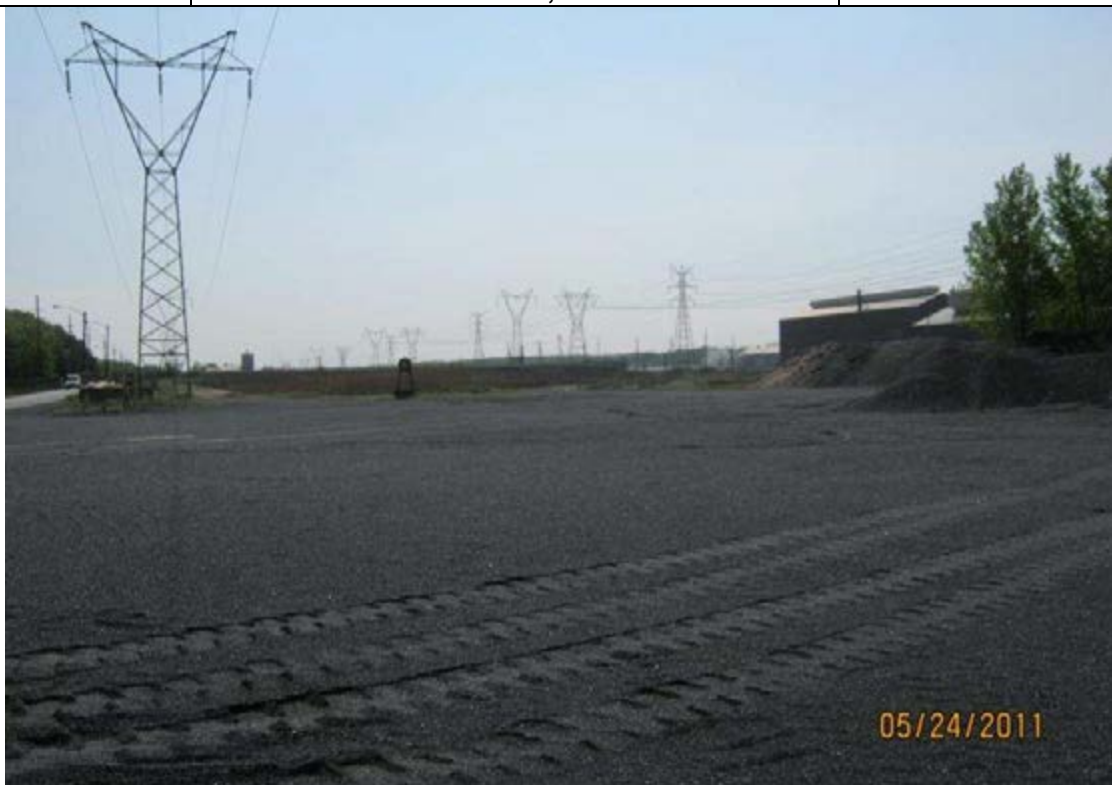
Description:
Bottom Ash Storage Area.

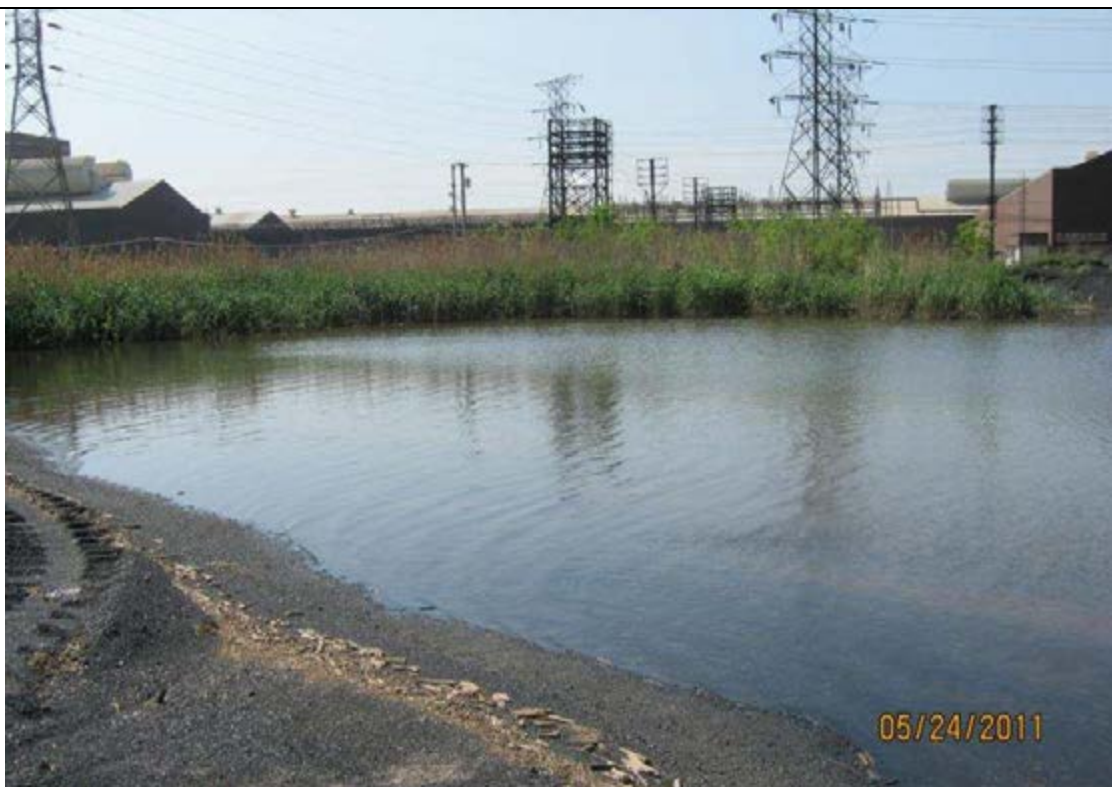
Photo No.
2

Description:
Bottom Ash Storage Area.

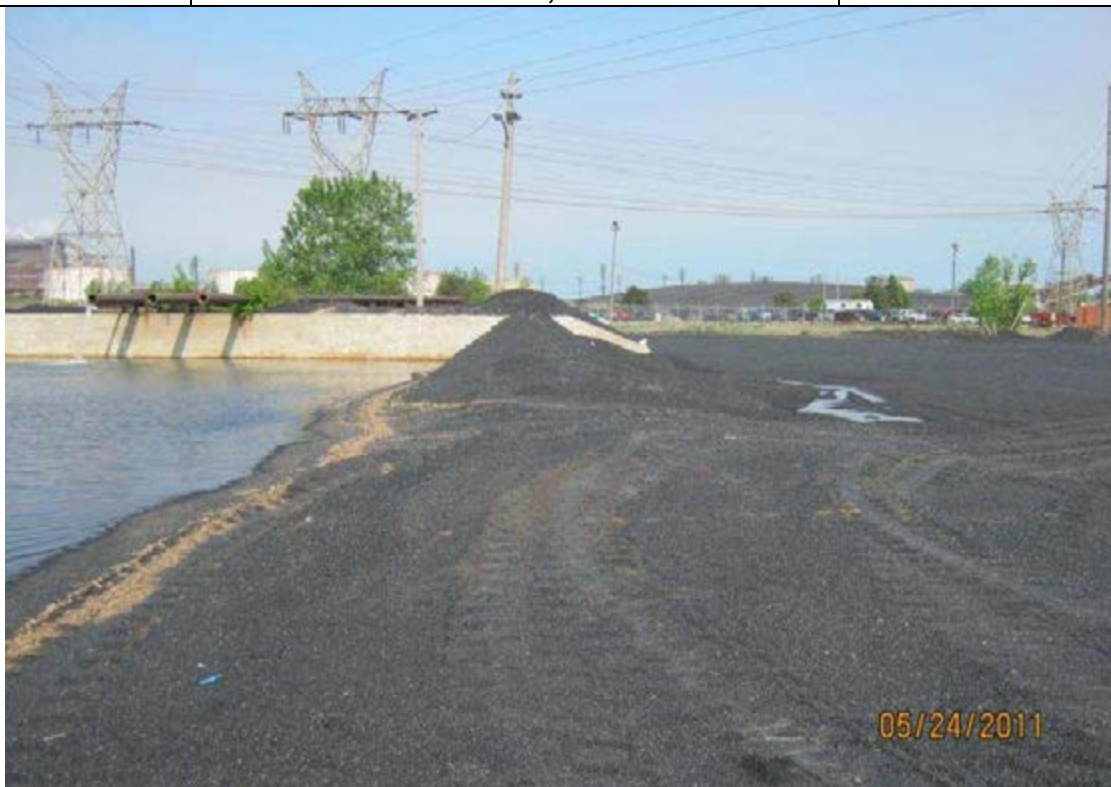
Description:
Bottom Ash Storage Area and outlet pipes.

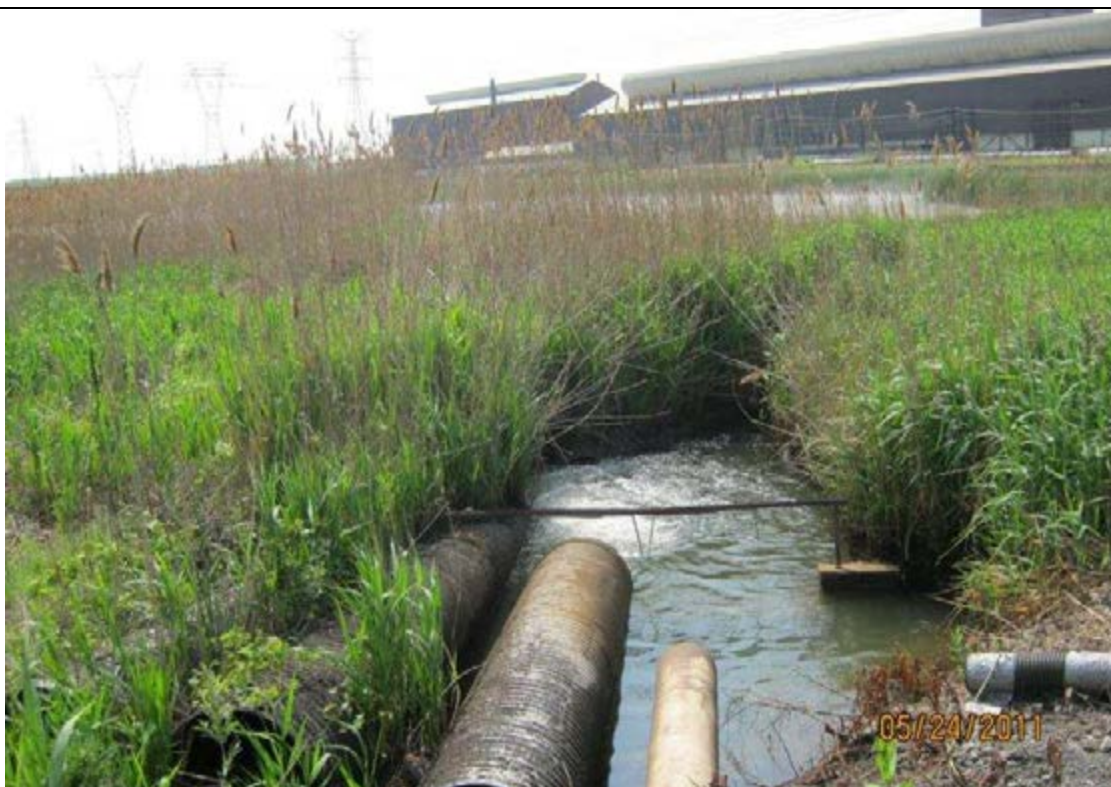
Photo No.
4

Description:
Pipes discharging into Primary Settling Basin No. 1.

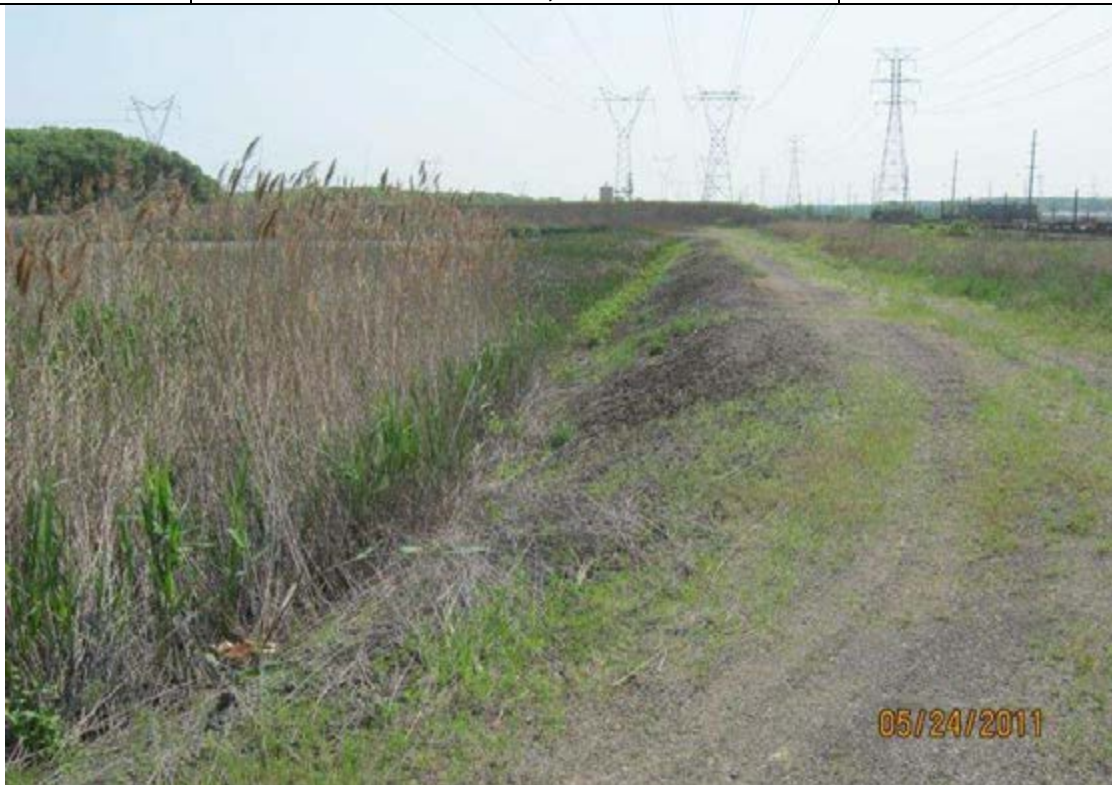
Description:
Interior slope of Primary Settling Pond No. 1 embankment.

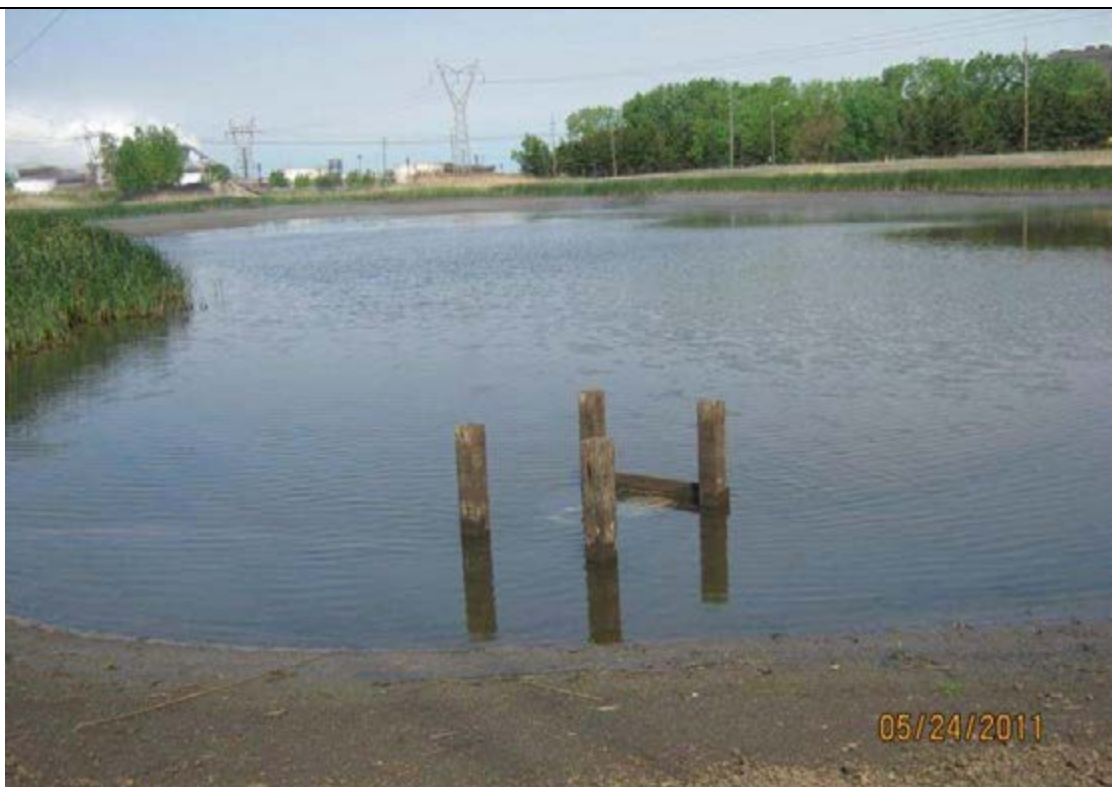
Photo No.
6

Description:
Primary Settling Pond No. 1, including the decant structure.

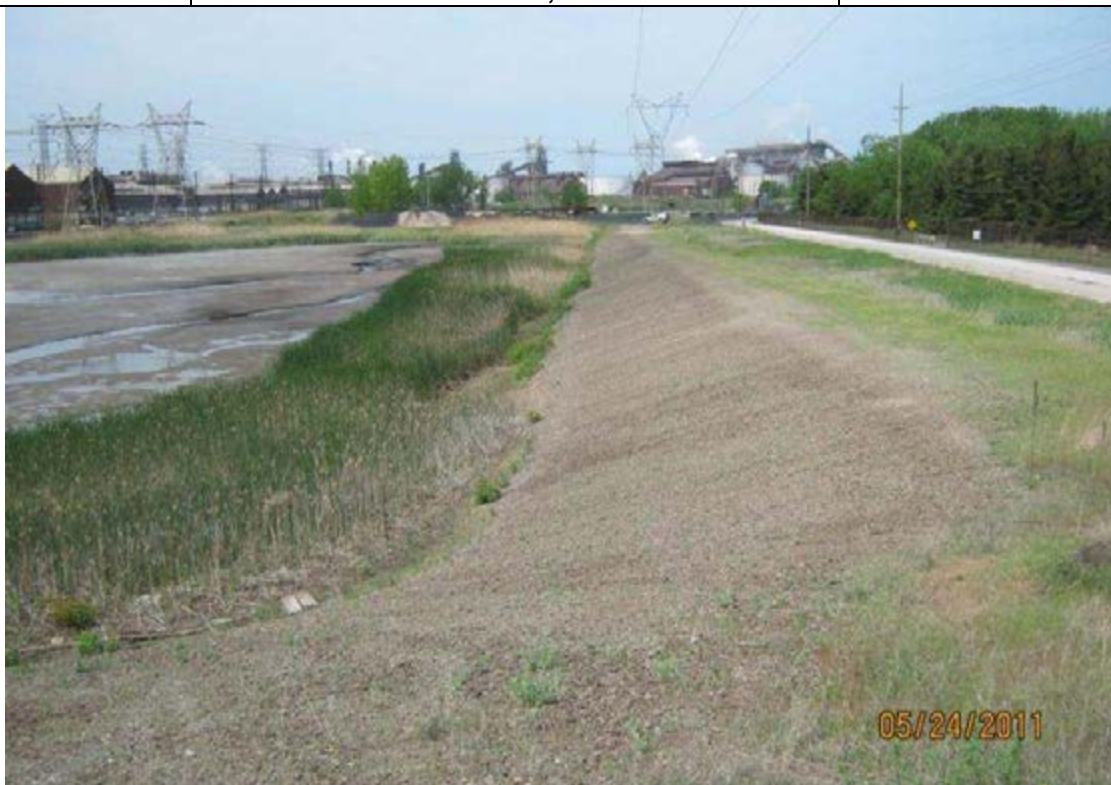
Description:
Interior of Primary Settling Pond No. 1.

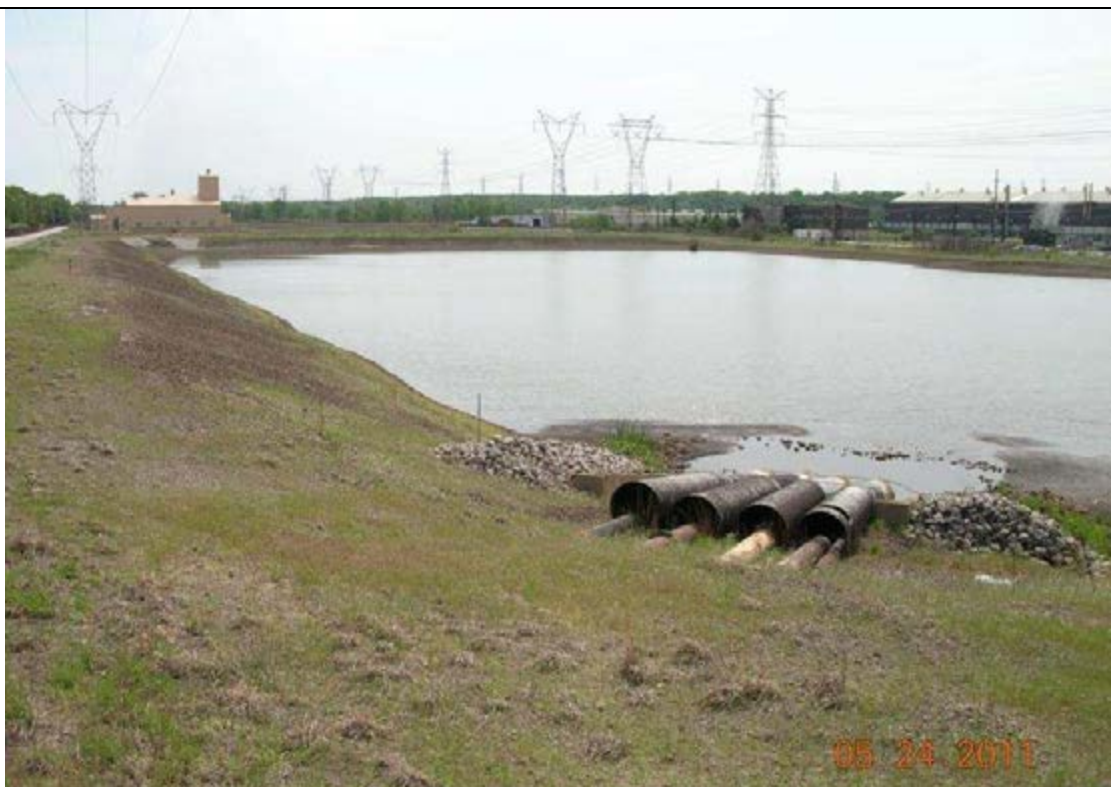
Photo No.
8

Description:
Primary Settling Pond No. 2.
Note the inlet discharge pipes from the BGS in the foreground.

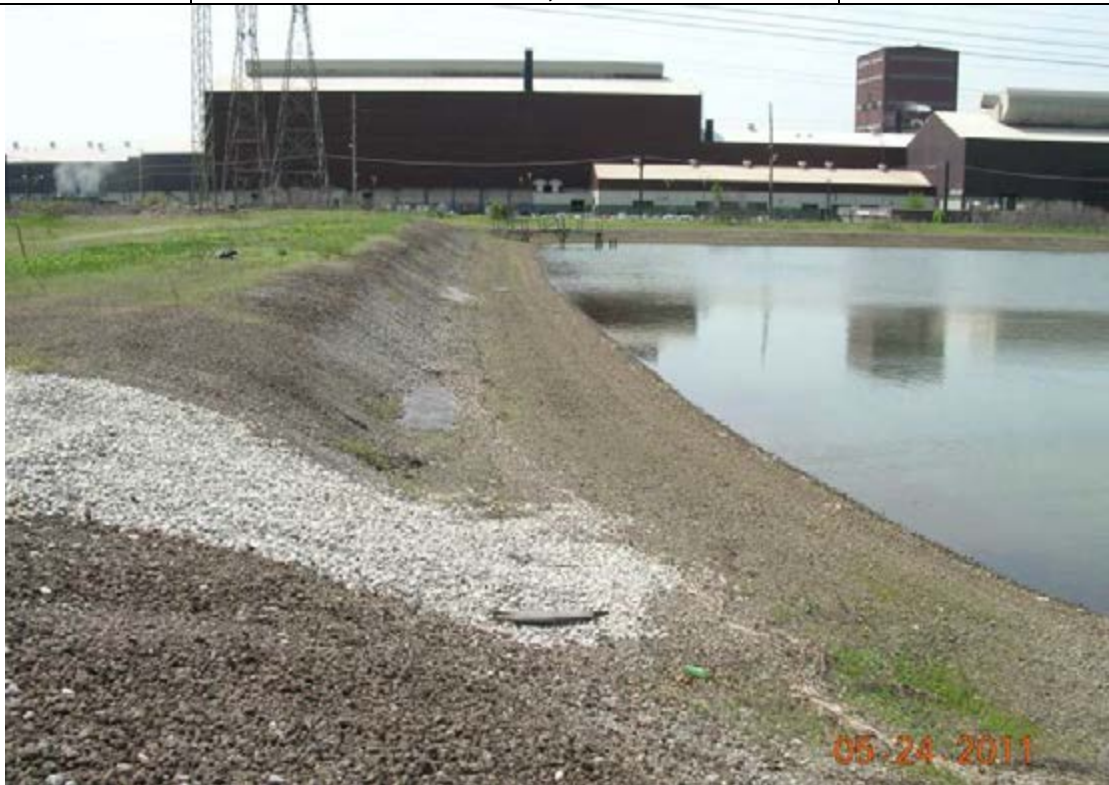
Description:
Eastern interior embankment of Primary Settling Pond No. 2.

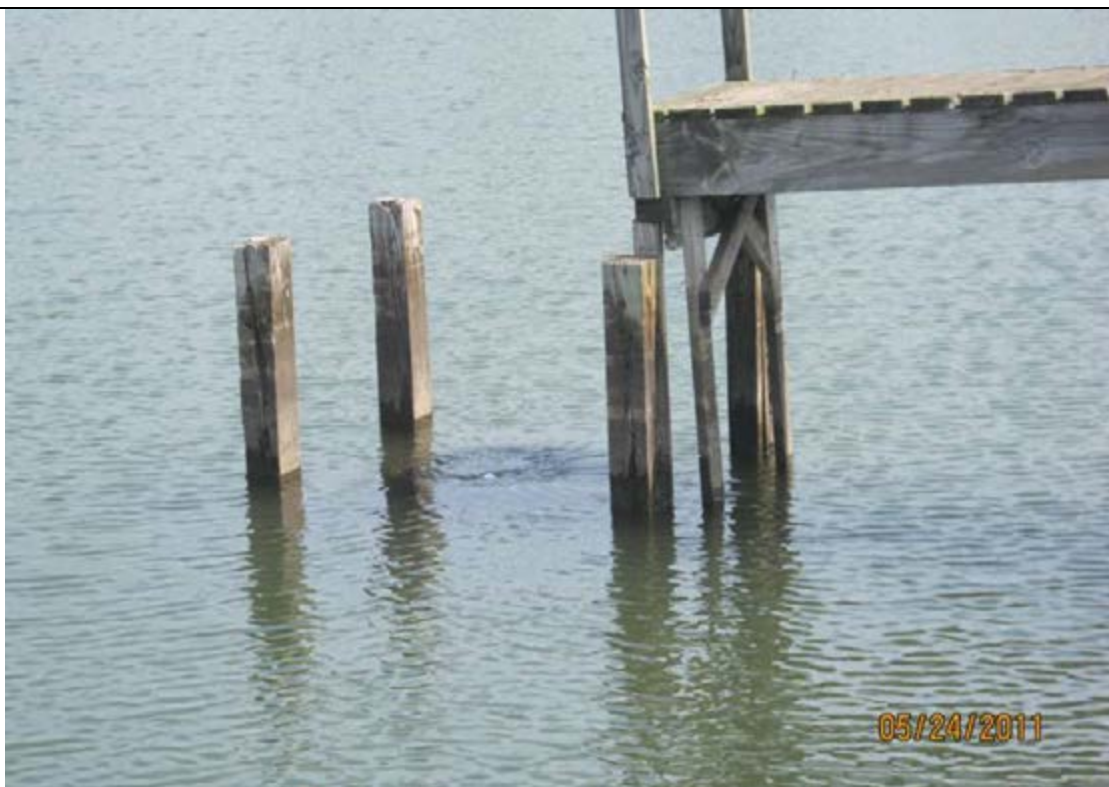
Photo No.
10

Description:
Decant structure in Primary Settling Pond No. 2.

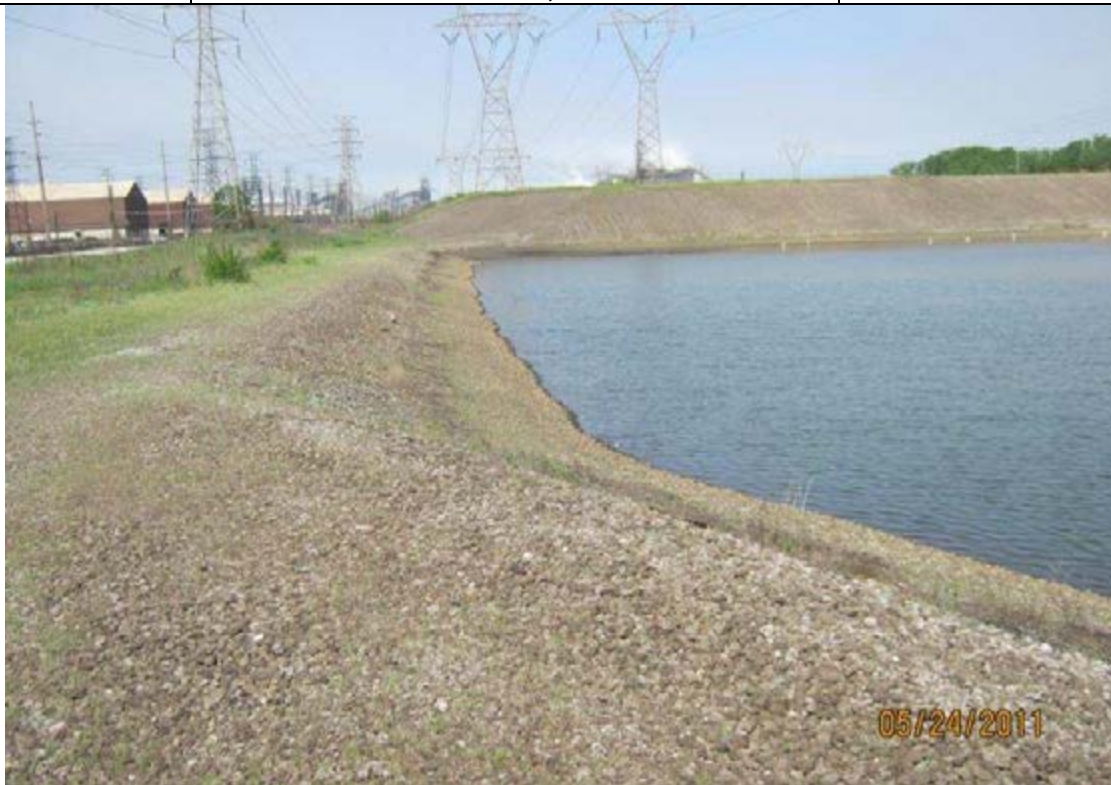
Description:
Interior southern embankment of Primary Settling Pond No. 2.

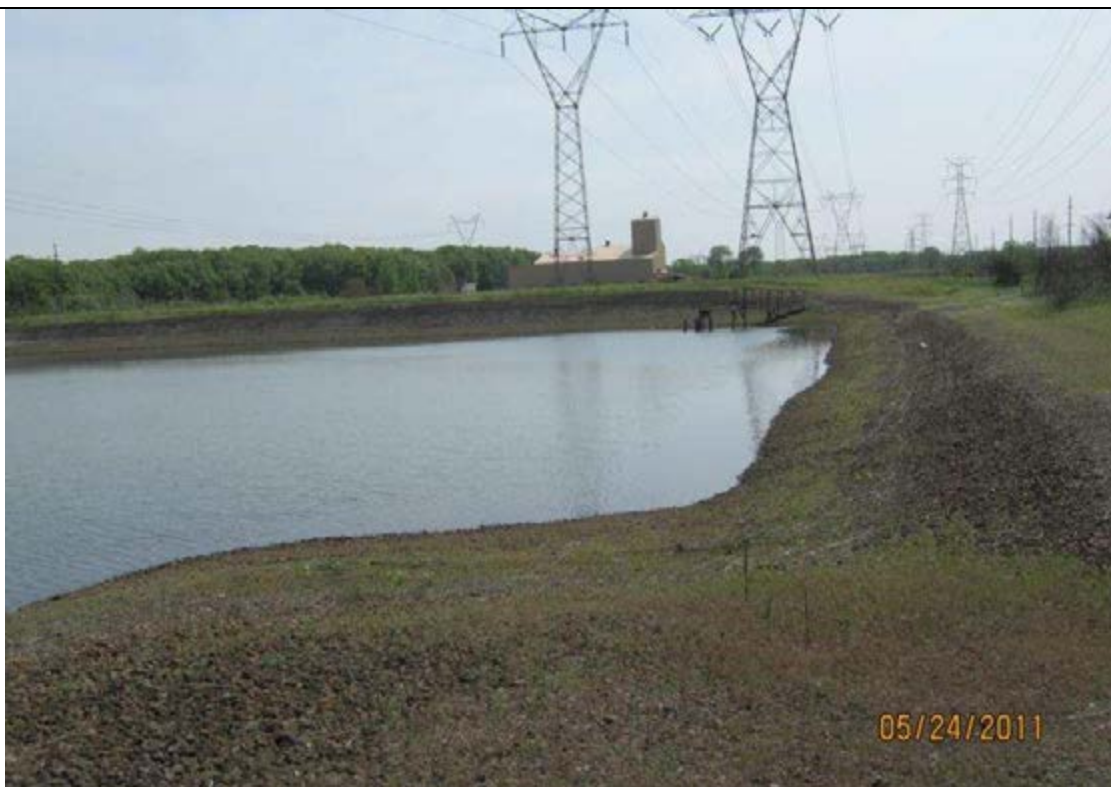
Photo No.
12

Description:
Interior southern embankment of Primary Settling Pond No. 2.

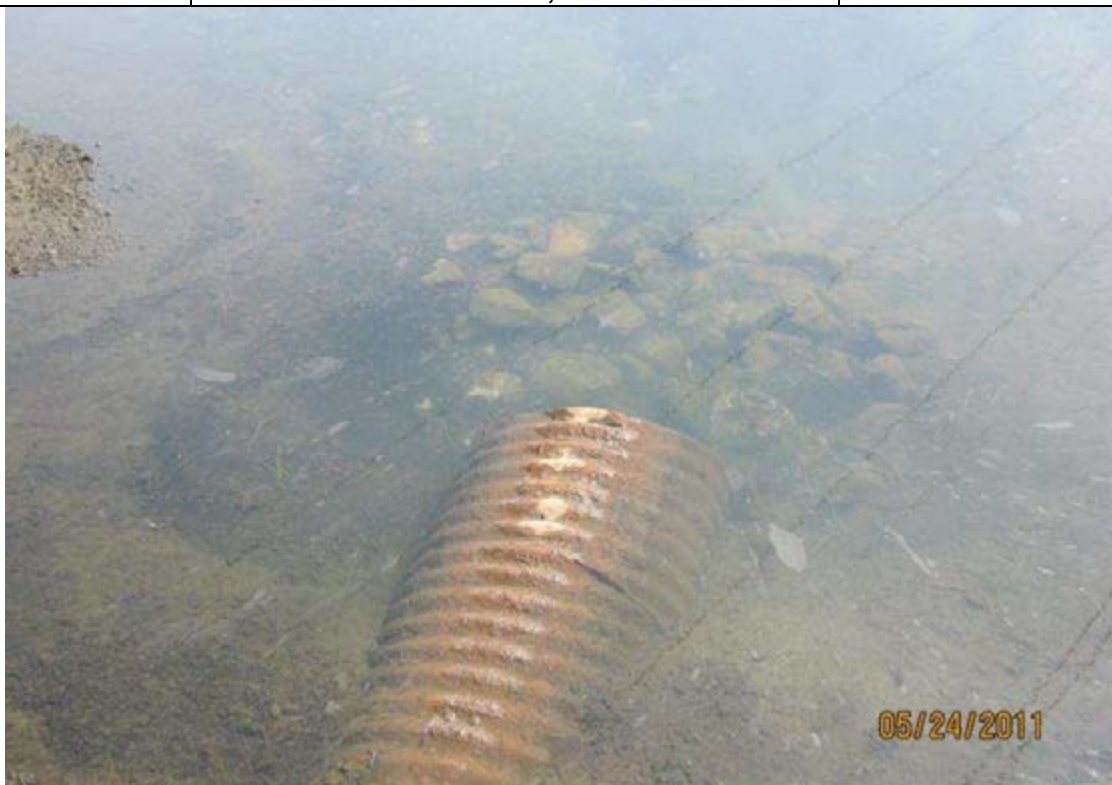
Description:
Inlet pipe into Primary Settling Pond No. 2 from the Bottom Ash Stormwater Area.

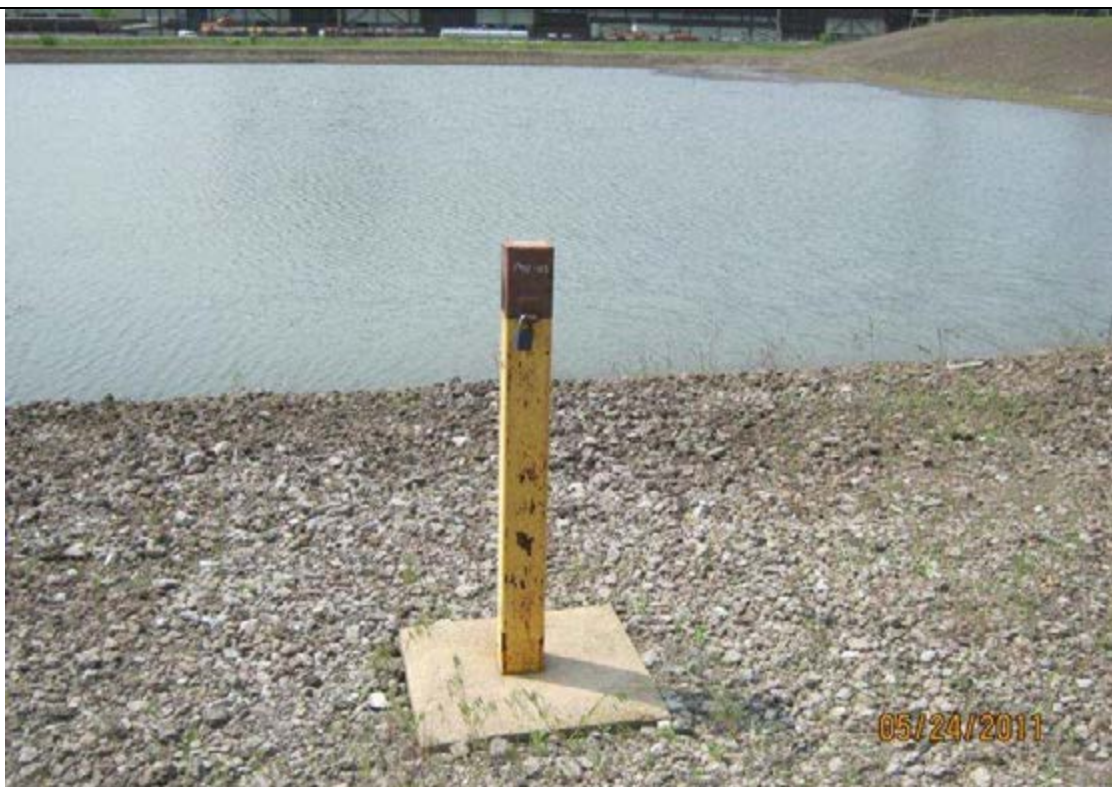
Photo No.
14

Description:
Monitoring well located on the north embankment of Primary Settling Pond No. 2.

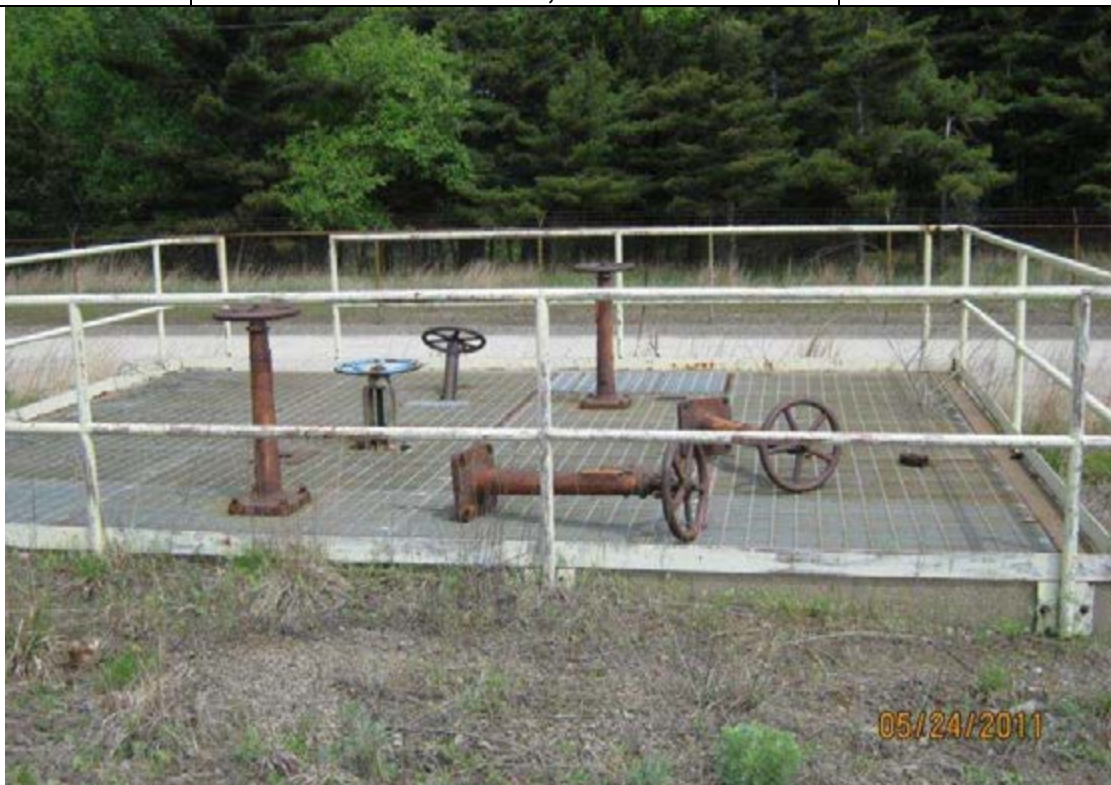
Valve pit to control and
direct the influent
wastewater flow from the
BGS.

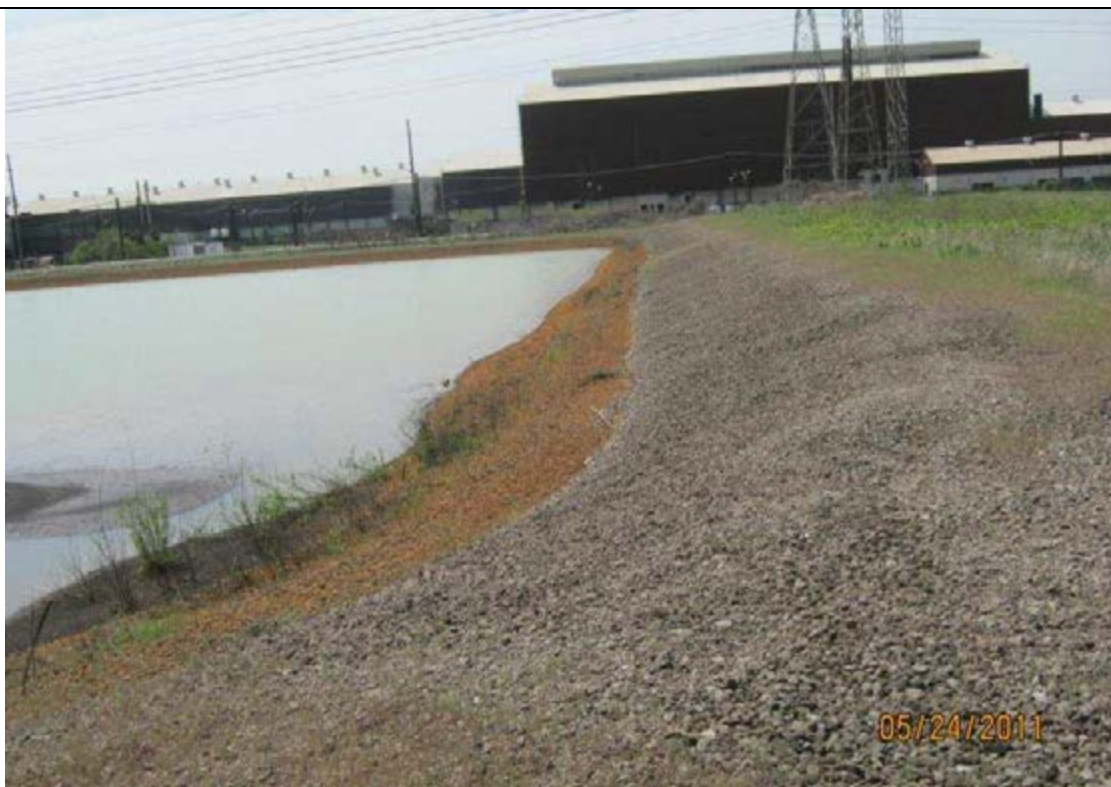
Photo No.
16

Western embankment of the
Secondary Settling Pond No.
2.

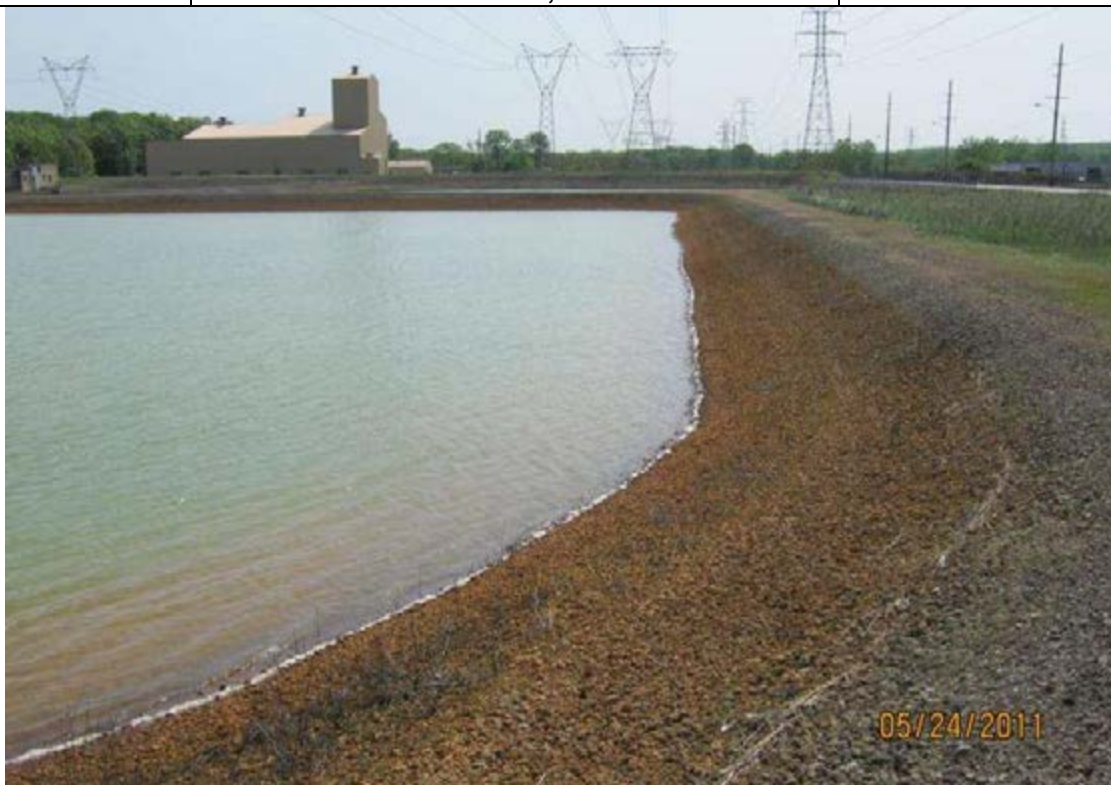
Description:
Southern embankment of
Secondary Settling Basin
No. 2.

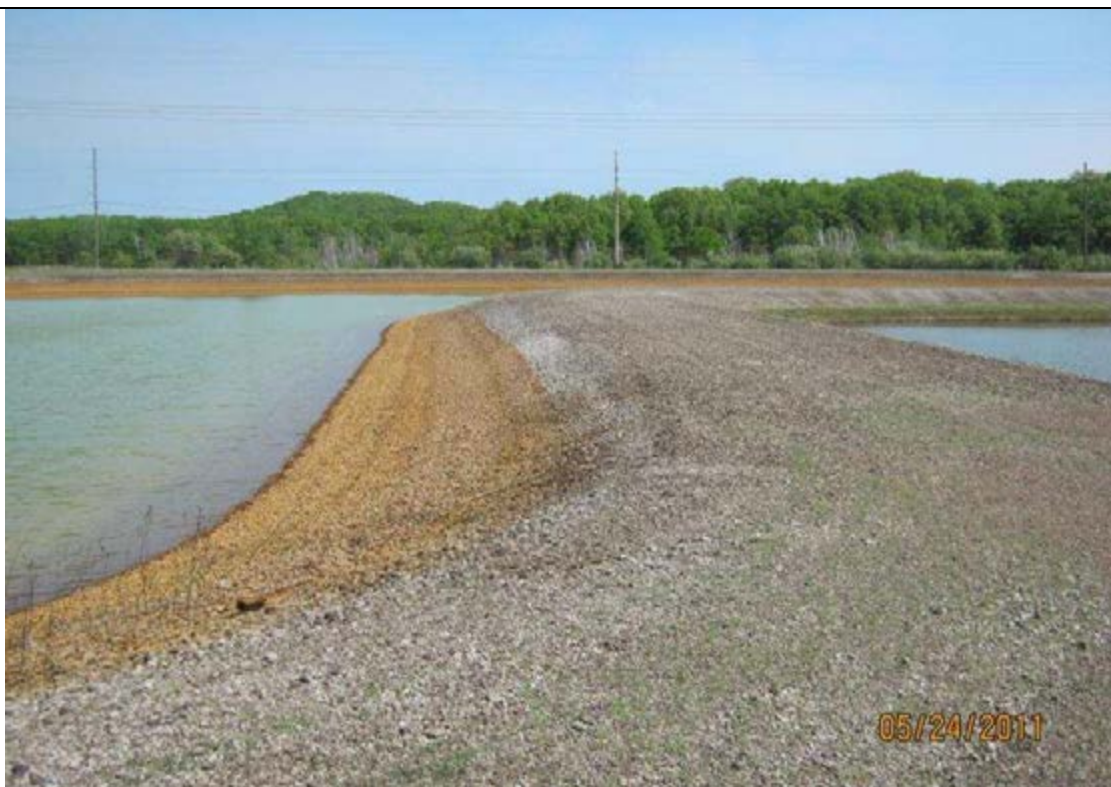
Photo No.
18

Description:
Embankment between
Secondary Settling Pond No.
2 (left side of photograph)
and Secondary Settling Pond
No. 1 (right side of
photograph).

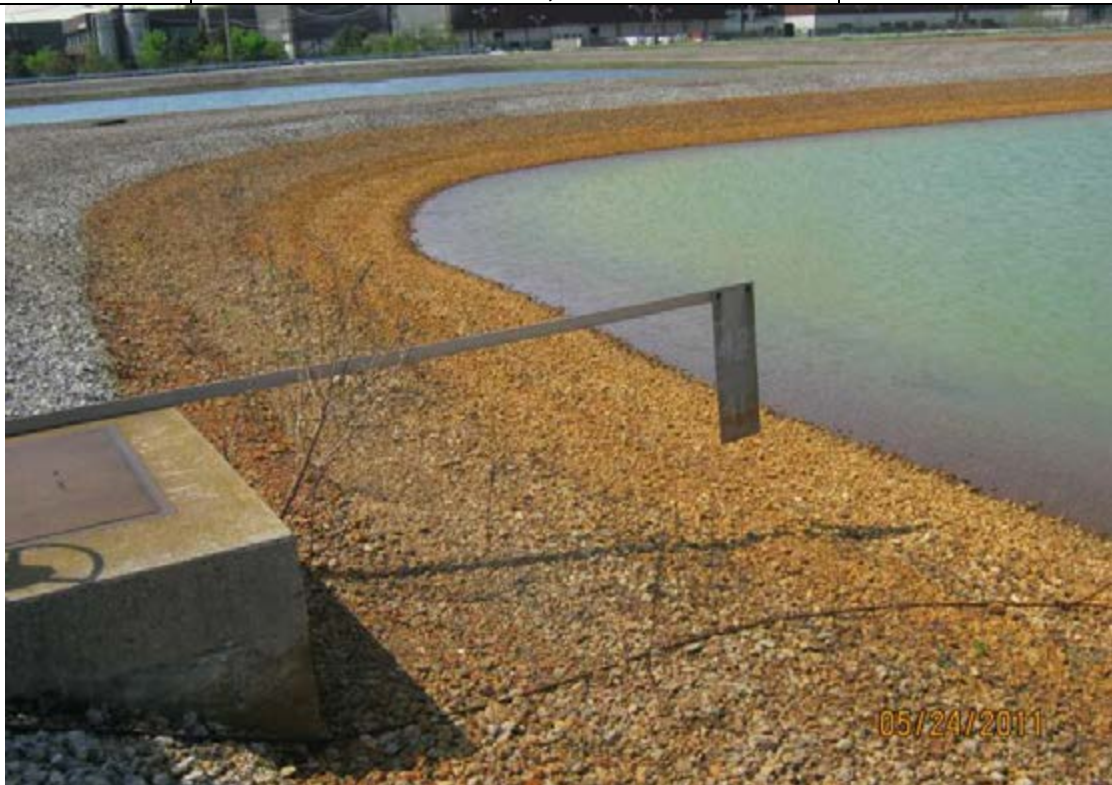
Description:
Staff gage in the Secondary Settling Pond No. 2 with a site specific elevation.

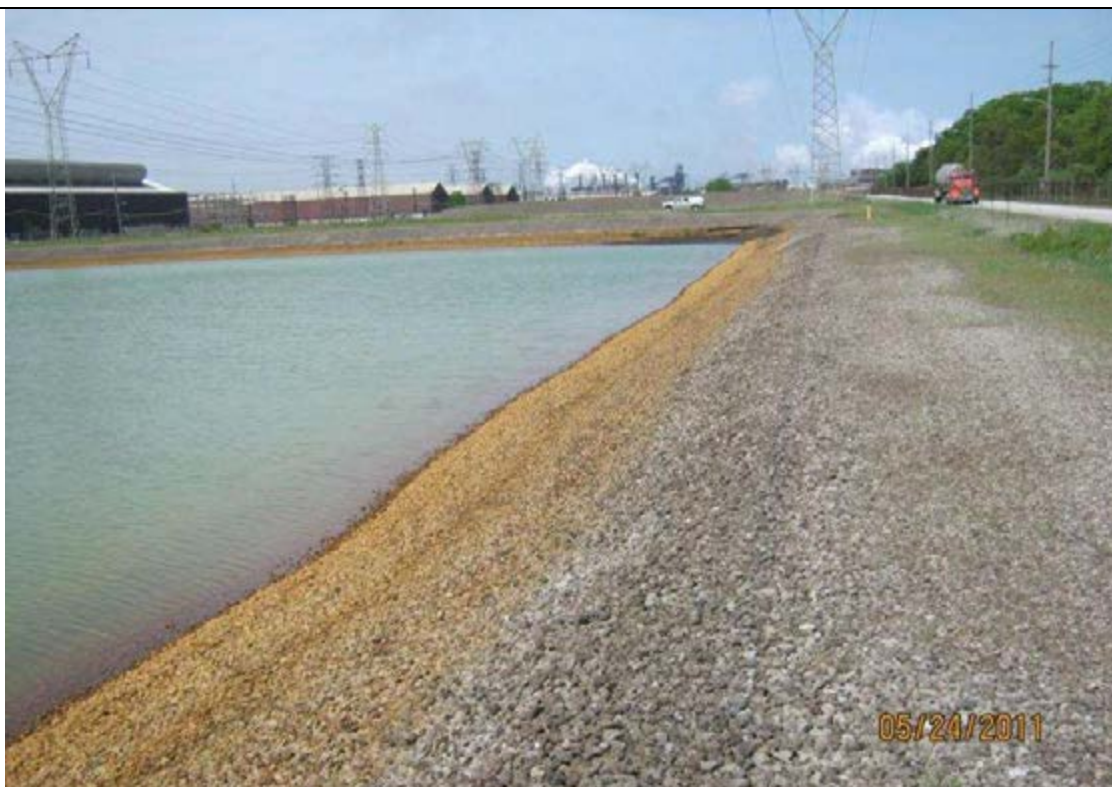
Photo No.
20

Description:
North embankment of the Secondary Settling Pond No. 2.

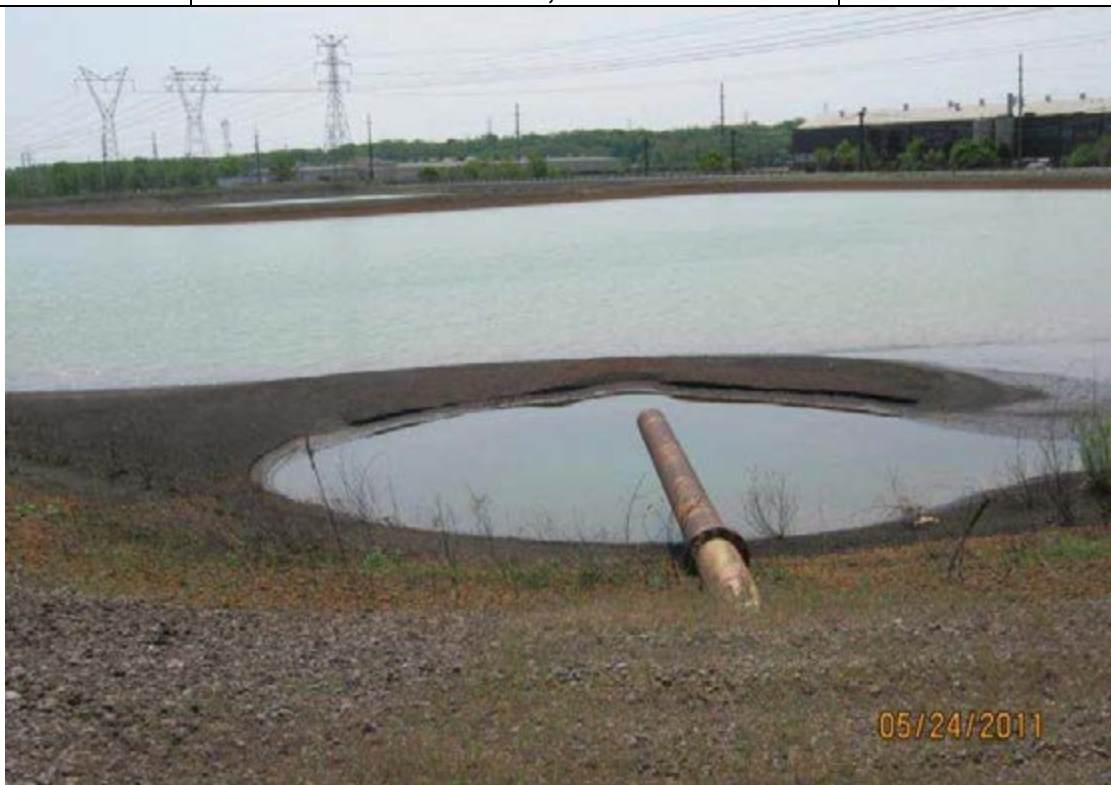
Description:
Inlet pipe into the Secondary
Settling Pond No. 2.

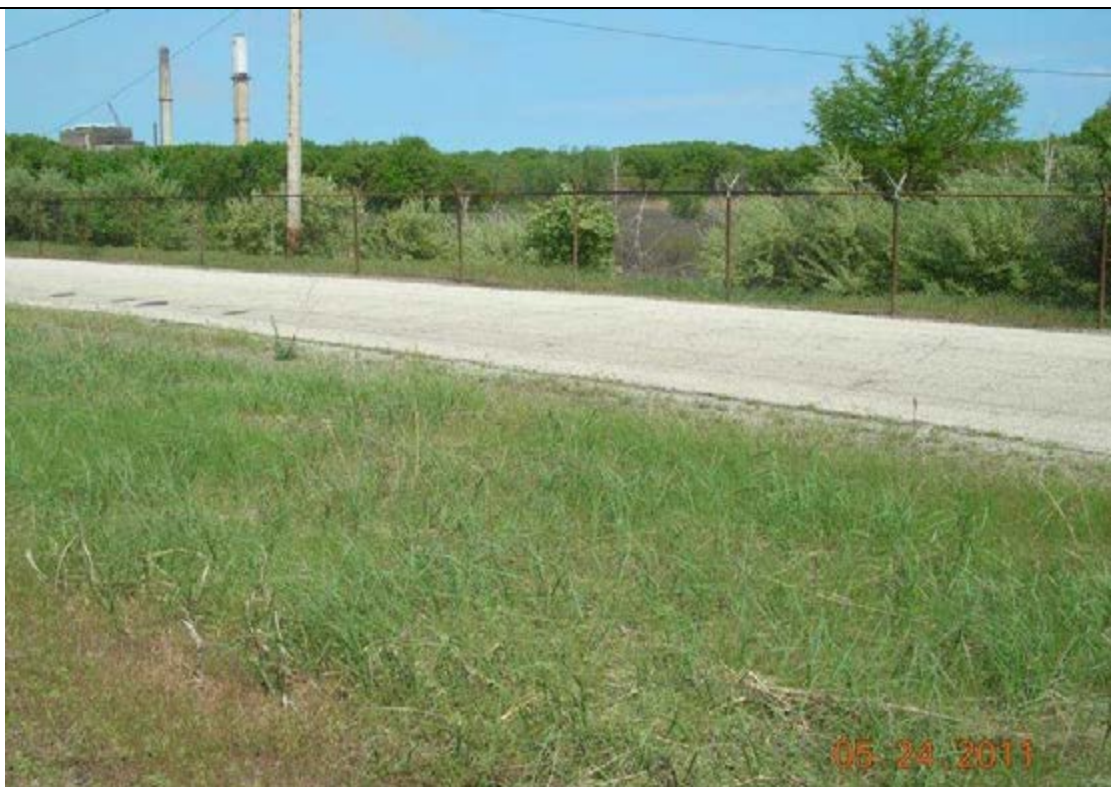
Photo No.
22

Description:
The Indiana National Dunes
Lakeshore that abuts the
north side of the
impoundments.

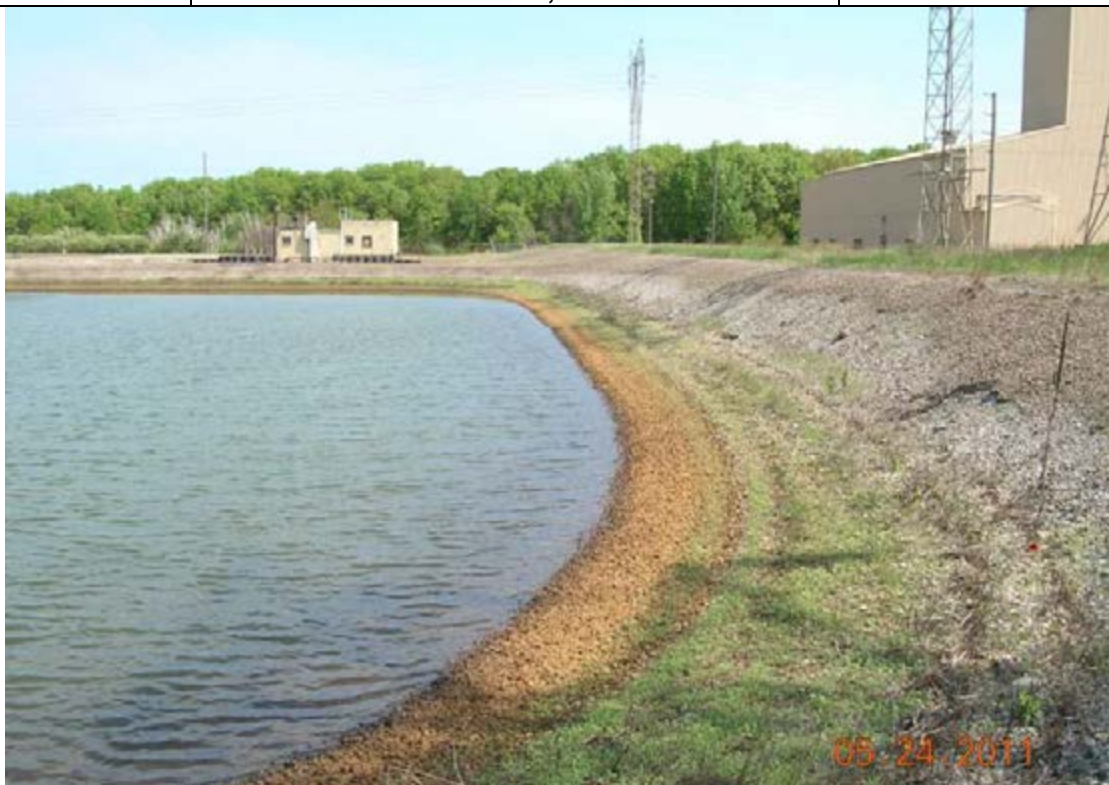
The east embankment of
Secondary Settling Pond No.
1. The vacant wastewater
treatment plant is on the
right of the photograph and
the Recycle Water
Pumphouse is in the
background.

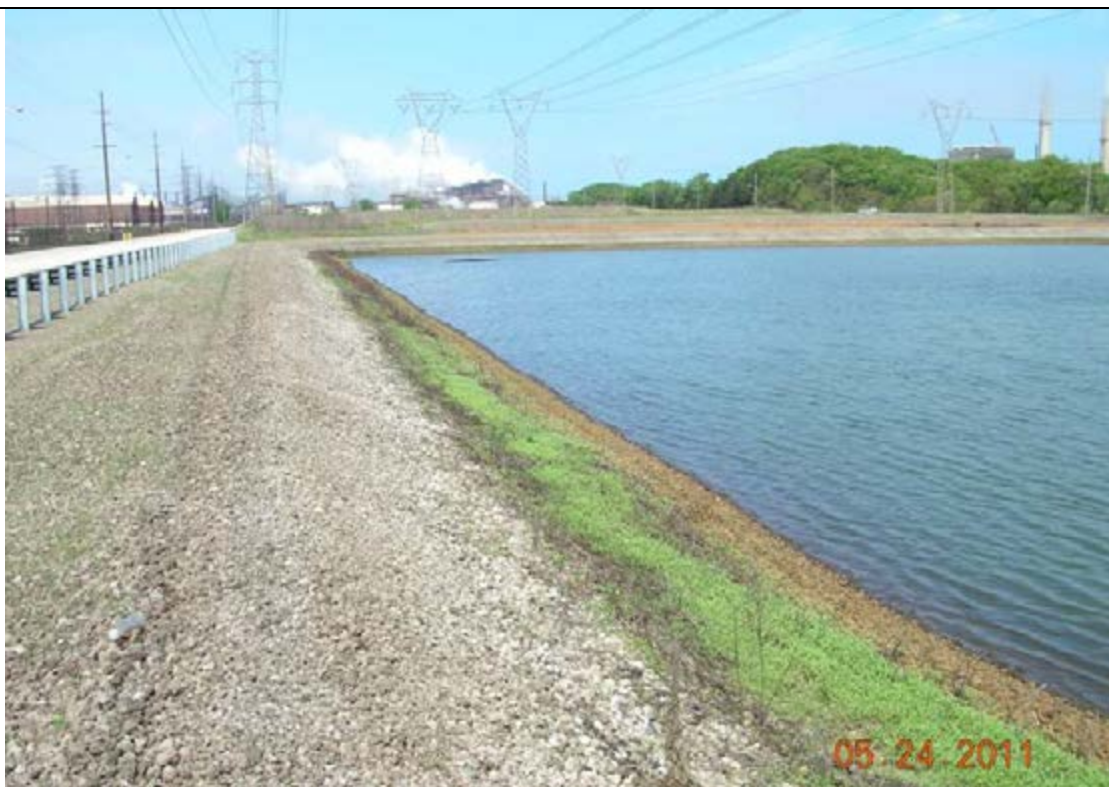
Photo No.
24

The south embankment of
Secondary Settling Pond No.
1.

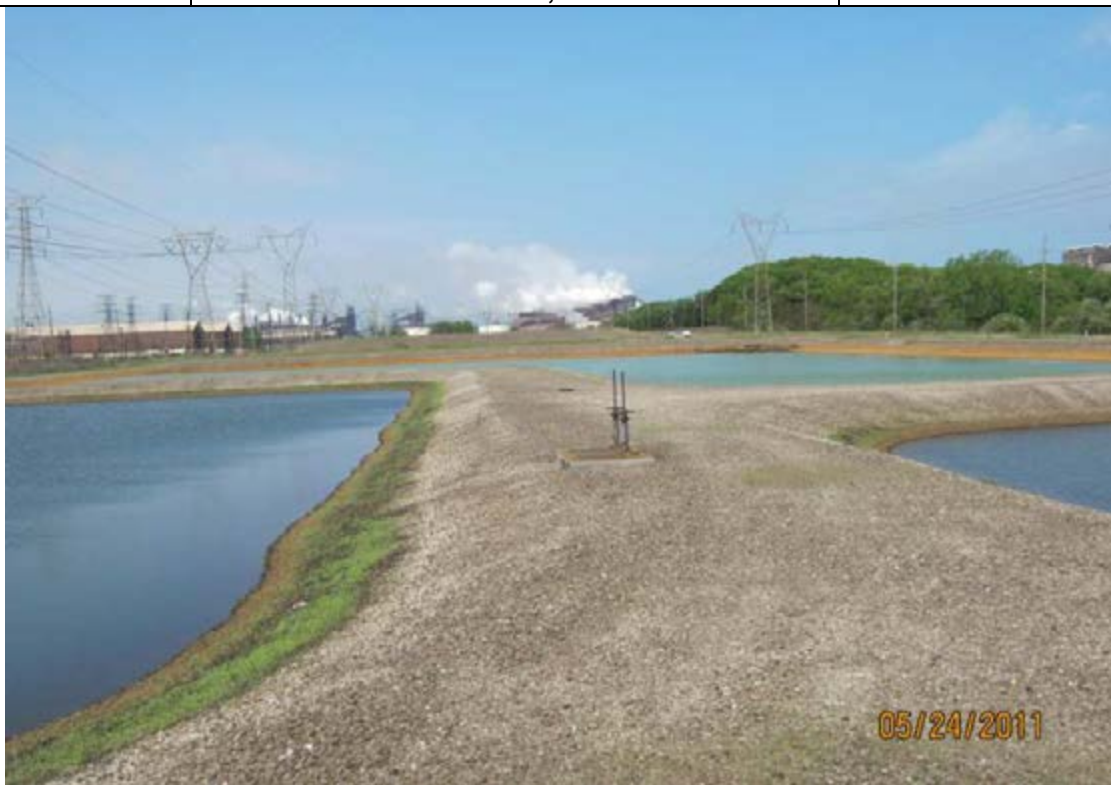
The embankment between the Secondary Settling Pond No. 1 (left side of photograph), Secondary Settling Pond No. 2 (background), and the Forebay (right side of photograph). The valves shown control the flow between the impoundments.
